GEOTECHNICAL REVIEW OF OFFSITE
IMPROVEMENT AREAS, AMENDMENT TO
PRELIMINARY GEOTECHNICAL EVALUATION,
WORLD LOGISTICS CENTER,
CITY OF MORENO VALLEY, CALIFORNIA

Subject: Geotechnical Review of Offsite Improvement Areas, Amendment to Preliminary Geotechnical Evaluation, World Logistics Center, City of Moreno Valley, California

In accordance with your request and authorization, we have performed a geotechnical review of three potential off-site water reservoir sites, four potential debris basins, and various sewer/water/roadway improvements for the World Logistics Center in the city of Moreno Valley, California. For the purposes of this report, we performed a site reconnaissance and reviewed available literature and aerial photographs pertinent to these sites. This report summarizes our findings and provides a geotechnical review describing the known and anticipated geotechnical conditions for each of the sites. Additional geotechnical studies are recommended as the design plans develop, i.e. water reservoir sites and access routes are selected, the basin sizes and designs are prepared, and the sewer/water/roadway improvements are developed.

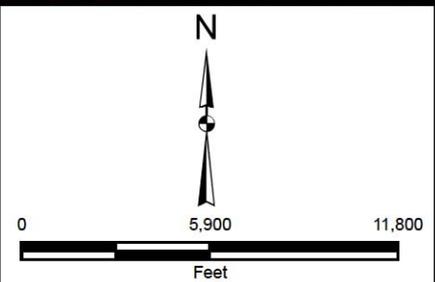
Figure 2

Project: 111061-126	Eng/Geol: SIS/RFR
Scale: 1" = 6,000'	Date: May 2012
Base Map: ESRI ArcGIS Online 2014 Geology: USGS, 2006, Geologic map of the San Bernardino and Santa Ana 30' x 60' quadrangles, California, Version 1.0, Open File Report 2006-1217 Author: (mmurphy)

REGIONAL GEOLOGY MAP
 World Logistics Center Specific Plan
 Moreno Valley, California

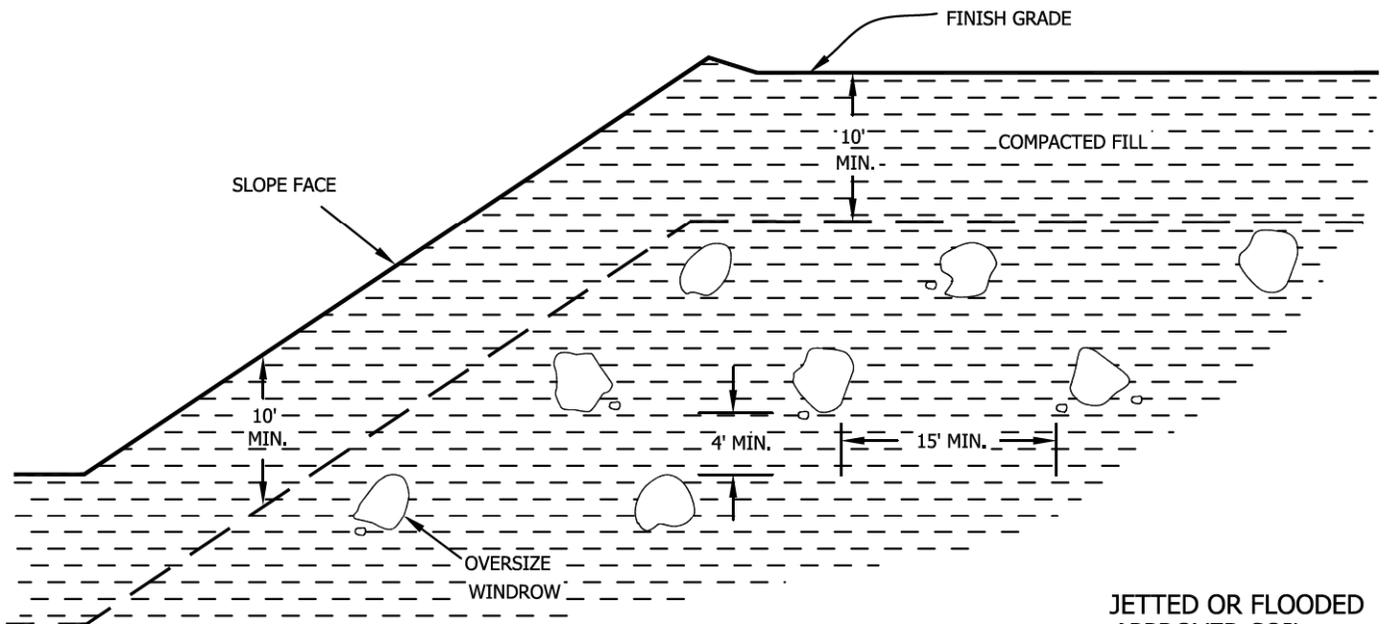
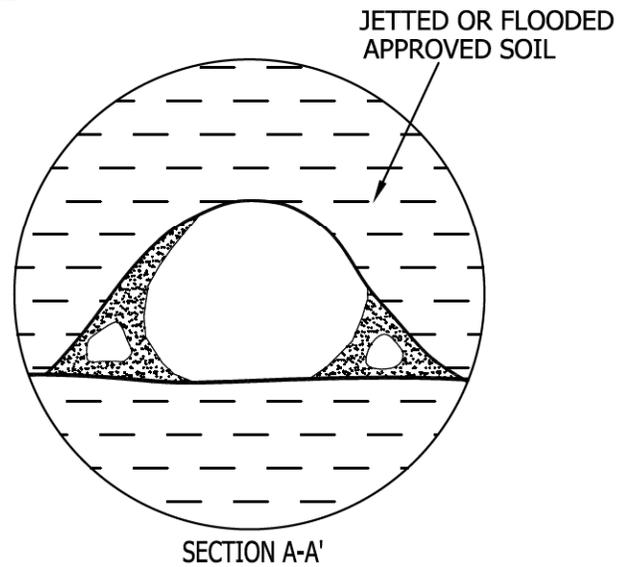
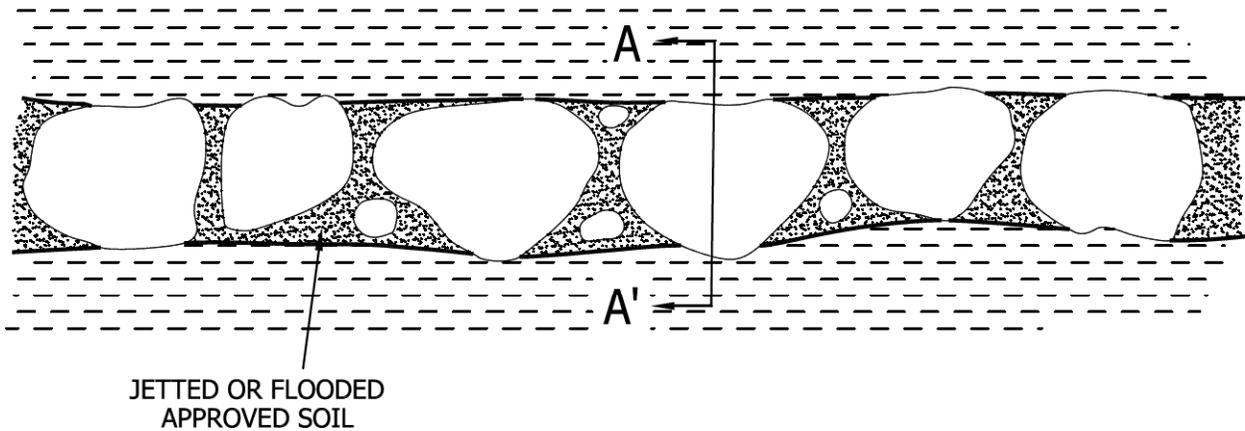
OVERSIZE ROCK DISPOSAL

- Oversize rock is larger than 8 inches in largest dimension.
- Backfill with approved soil jetted or flooded in place to fill all the voids.
- Do not bury rock within 10 feet of finish grade.
- Windrow of buried rock shall be parallel to the finished slope face.

PROFILE ALONG WINDROW

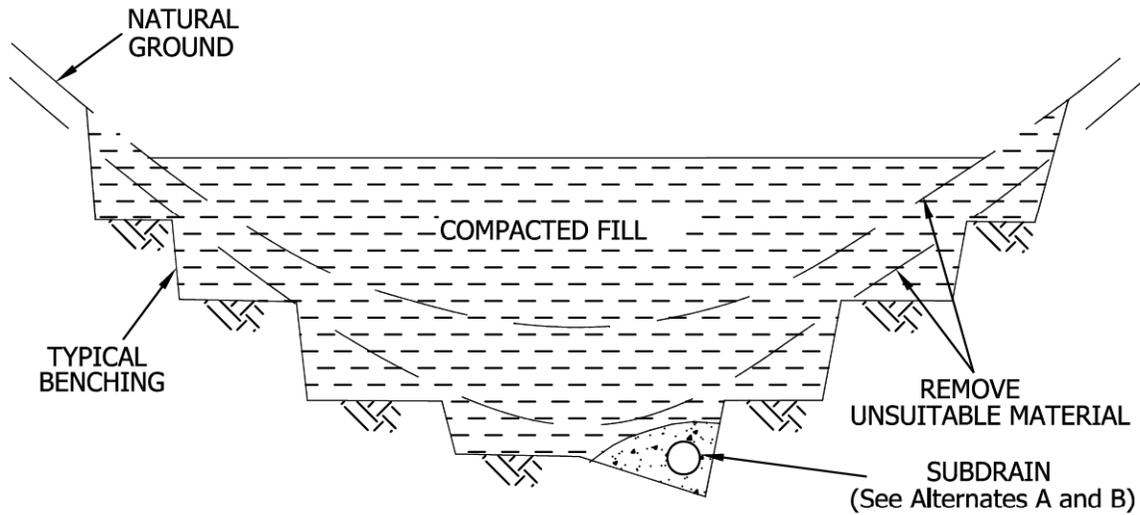
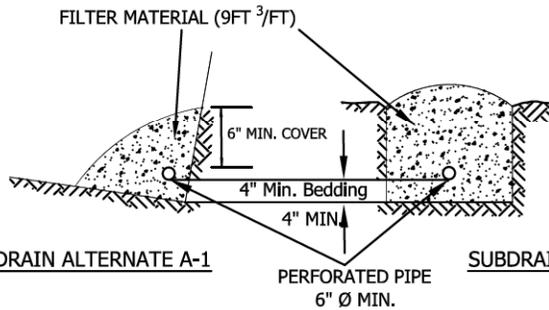
SUBDRAIN ALTERNATE A

PERFORATED PIPE SURROUNDED WITH FILTER MATERIAL

FILTER MATERIAL
 FILTER MATERIAL SHALL BE CLASS 2 PERMEABLE MATERIAL PER STATE OF CALIFORNIA STANDARD SPECIFICATION, OR APPROVED ALTERNATE. CLASS 2 GRADING AS FOLLOWS:

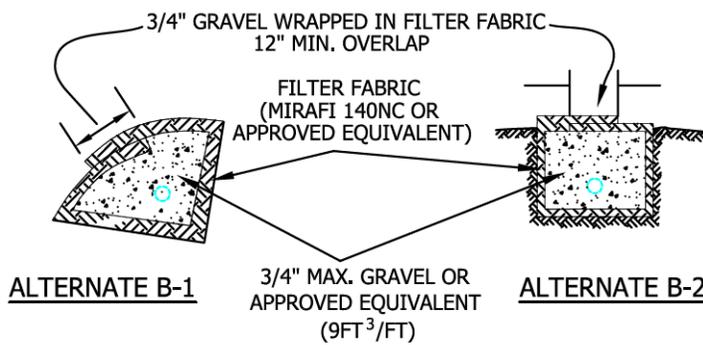
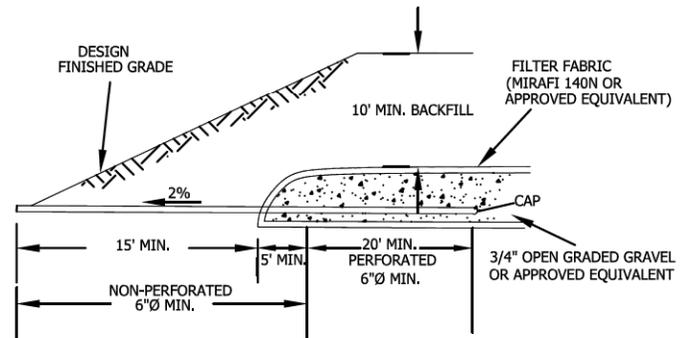
SUBDRAIN ALTERNATE B

DETAIL OF CANYON SUBDRAIN TERMINAL

○ PERFORATED PIPE IS OPTIONAL PER GOVERNING AGENCY'S REQUIREMENTS

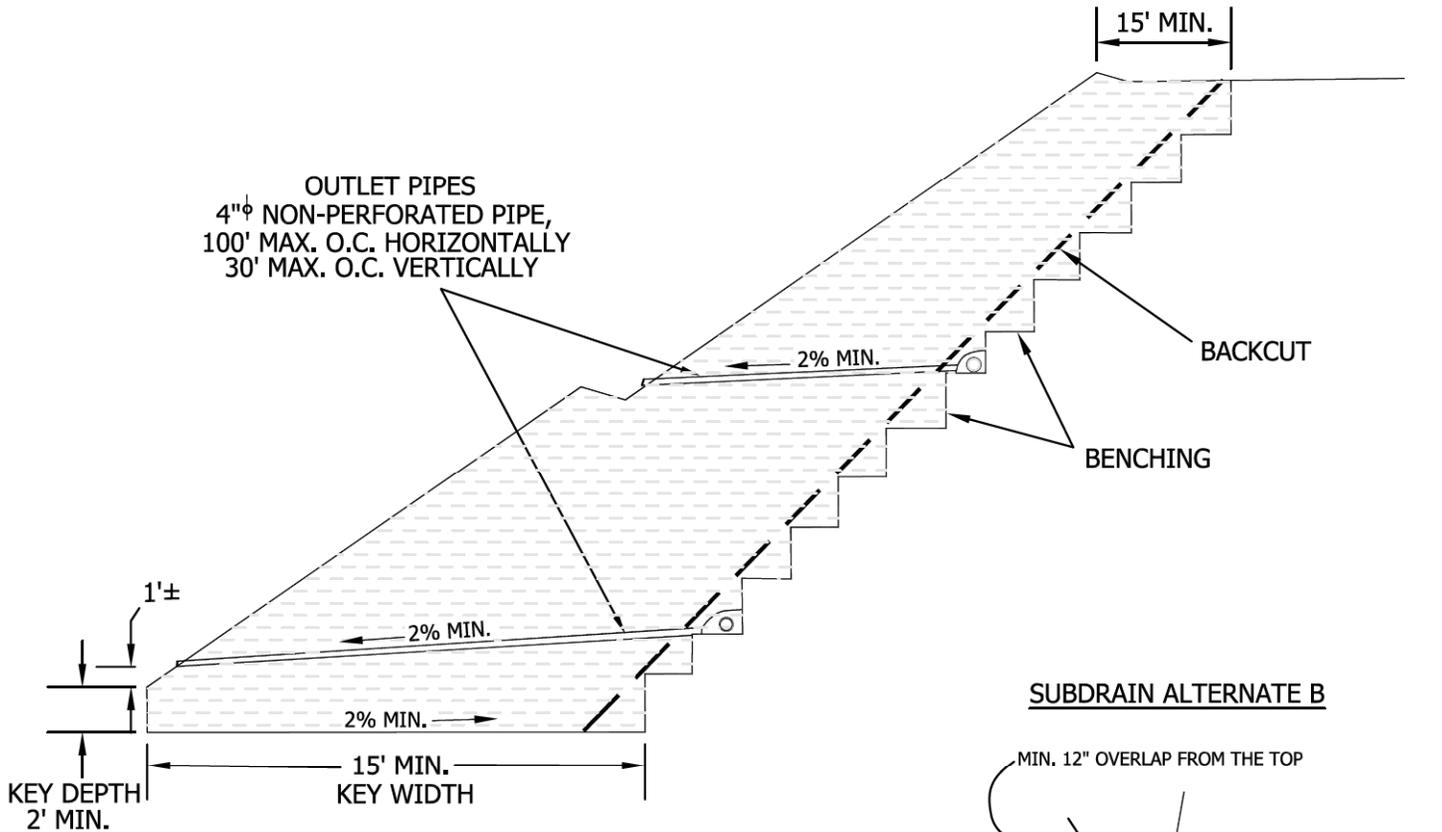
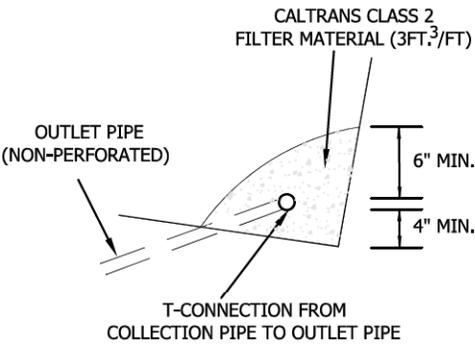
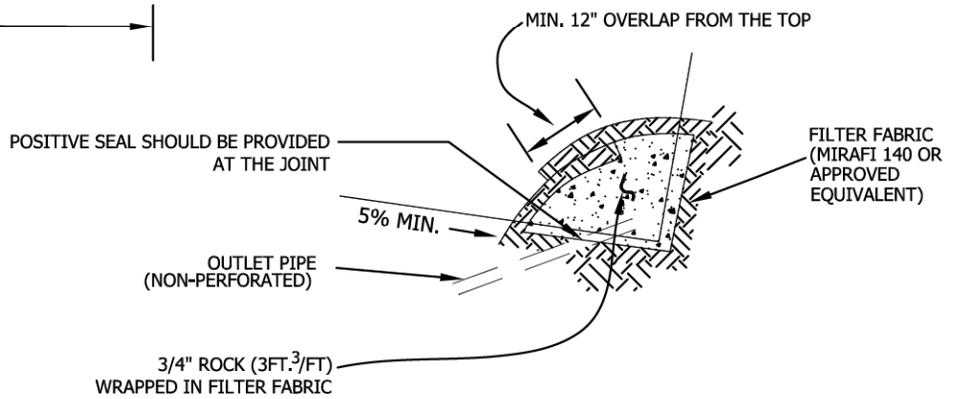
**BUTTRESS OR
REPLACEMENT FILL
SUBDRAINS**

SUBDRAIN ALTERNATE A

SUBDRAIN ALTERNATE B

- SUBDRAIN INSTALLATION - Subdrain collector pipe shall be installed with perforations down or, unless otherwise designated by the geotechnical consultant. Outlet pipes shall be non-perforated pipe. The subdrain pipe shall have at least 8 perforations uniformly spaced per foot. Perforation shall be 1/4" to 1/2" if drilled holes are used. All subdrain pipes shall have a gradient at least 2% towards the outlet.
- SUBDRAIN PIPE - Subdrain pipe shall be ASTM D2751, ASTM D1527 (Schedule 40) or SDR 23.5 ABS pipe or ASTM D3034 (Schedule 40) or SDR 23.5 PVC pipe.
- All outlet pipe shall be placed in a trench and, after fill is placed above it, rodded to verify integrity.
