PHASE I ENVIRONMENTAL SITE ASSESSMENT REPORT

INDIAN BUSINESS PARK INDIAN STREET AND KRAMERIA AVENUE MORENO VALLEY, CALIFORNIA

Farallon PN: 1071-007 (Task 6)

March 23, 2015

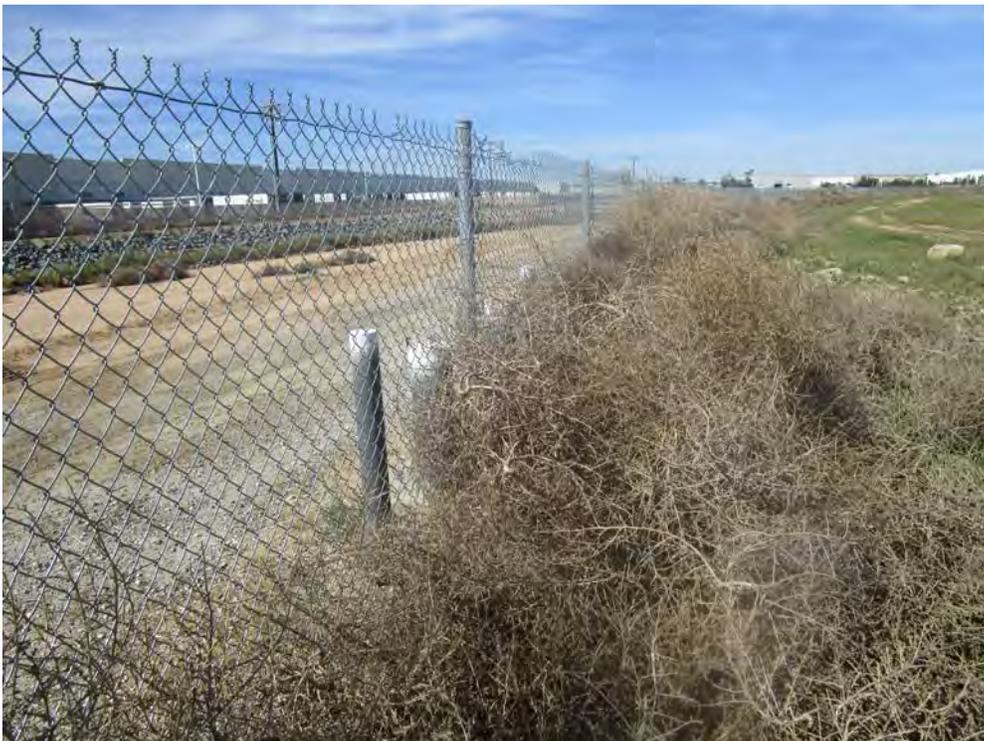
Photograph 4: Monitoring wells adjacent to southern property line of Lot 1.

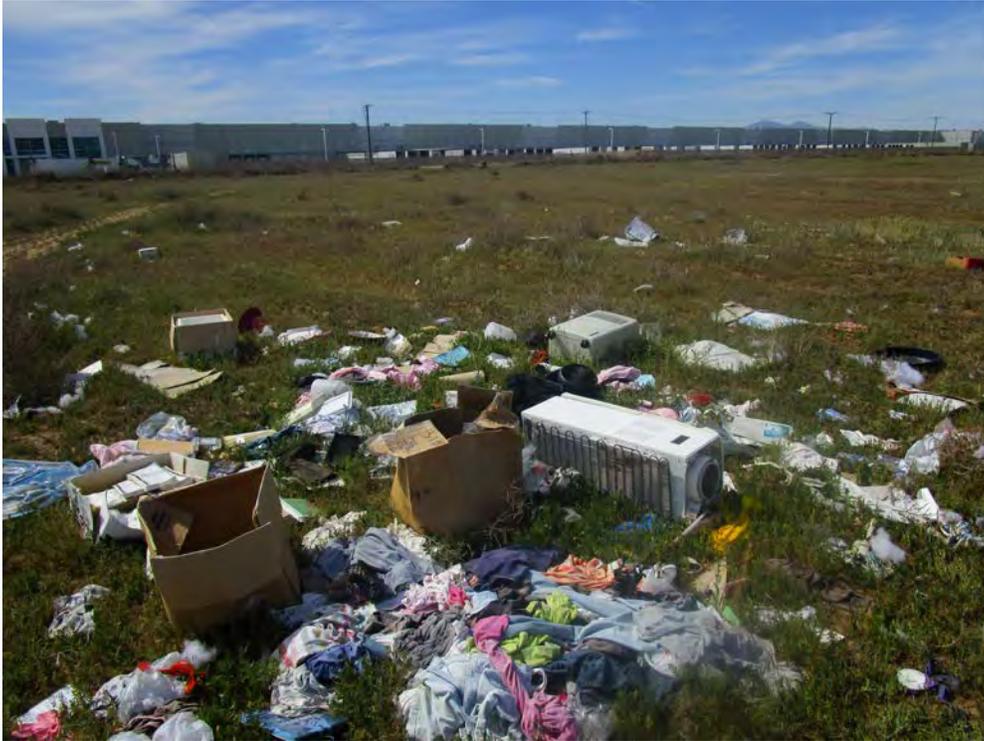
Farallon observed tires, construction debris, and minor trash in debris piles and scattered throughout the Site, primarily on Lot 1. These waste materials appeared to be non-hazardous solid wastes and are considered a de minimis condition for the Site.

Photograph 5: Debris pile along eastern property line of Lot 1.

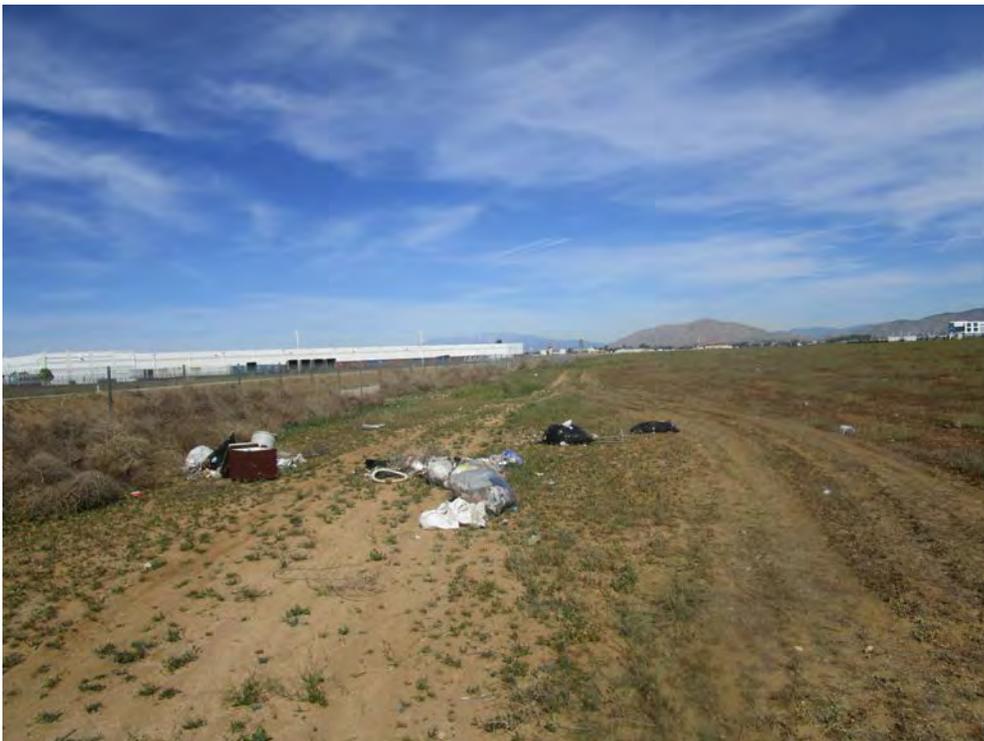
Photograph 6: Debris pile along western property line of Lot 1.

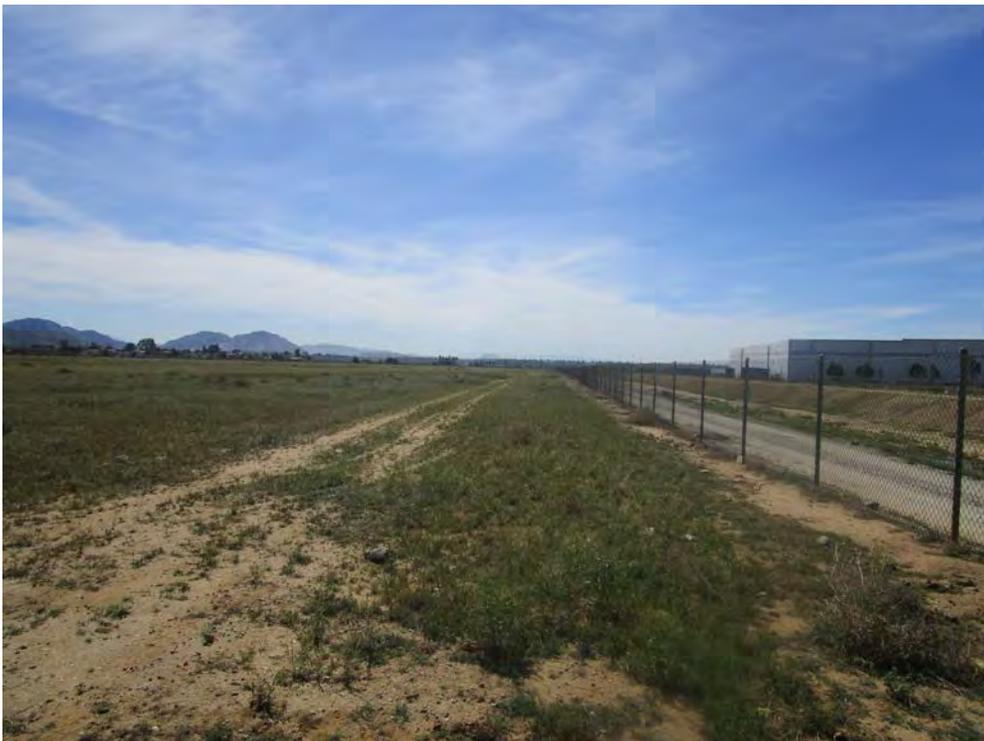
Photograph 8: Southern property line of Lot 2 adjacent to Perris Valley Storm Drain.

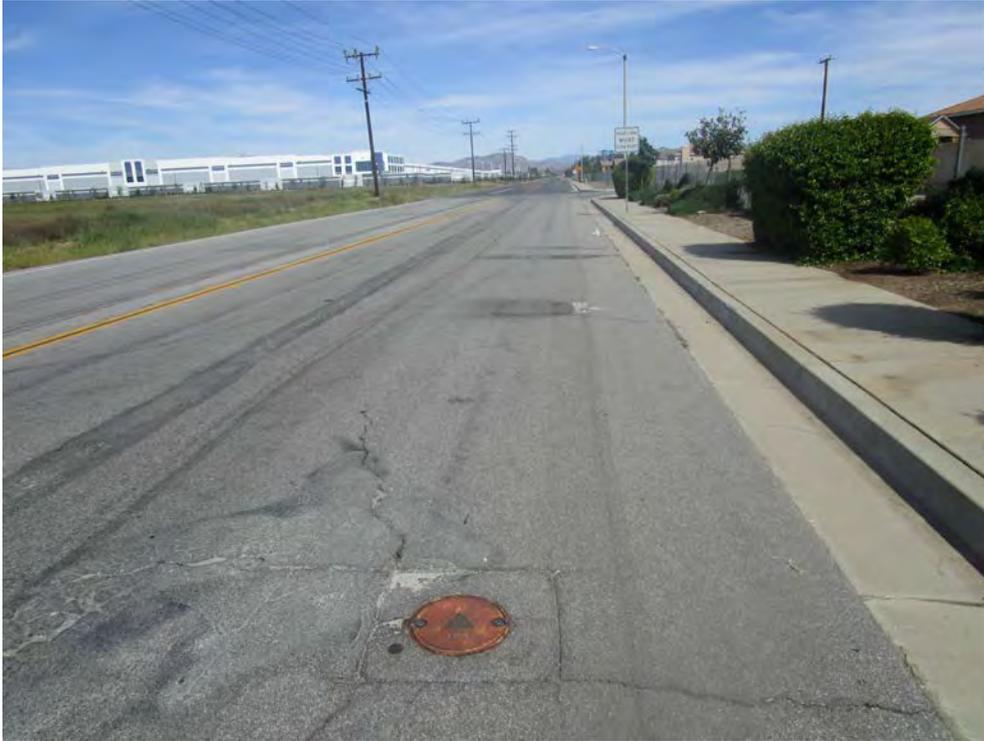
Farallon observed evidence of monitoring wells on adjacent properties and roadways, which have been identified as part of MAFB groundwater investigations and remediation. The monitoring wells are further discussed in Section 7.1.2, Surrounding Property Listings. No visual evidence of recognized environmental conditions was observed on adjacent or nearby properties during the site reconnaissance, with the exception of MAFB, discussed in Section 7.1.2, Surrounding Property Listings.

Photograph 11: Both monitoring wells on Indian Street.

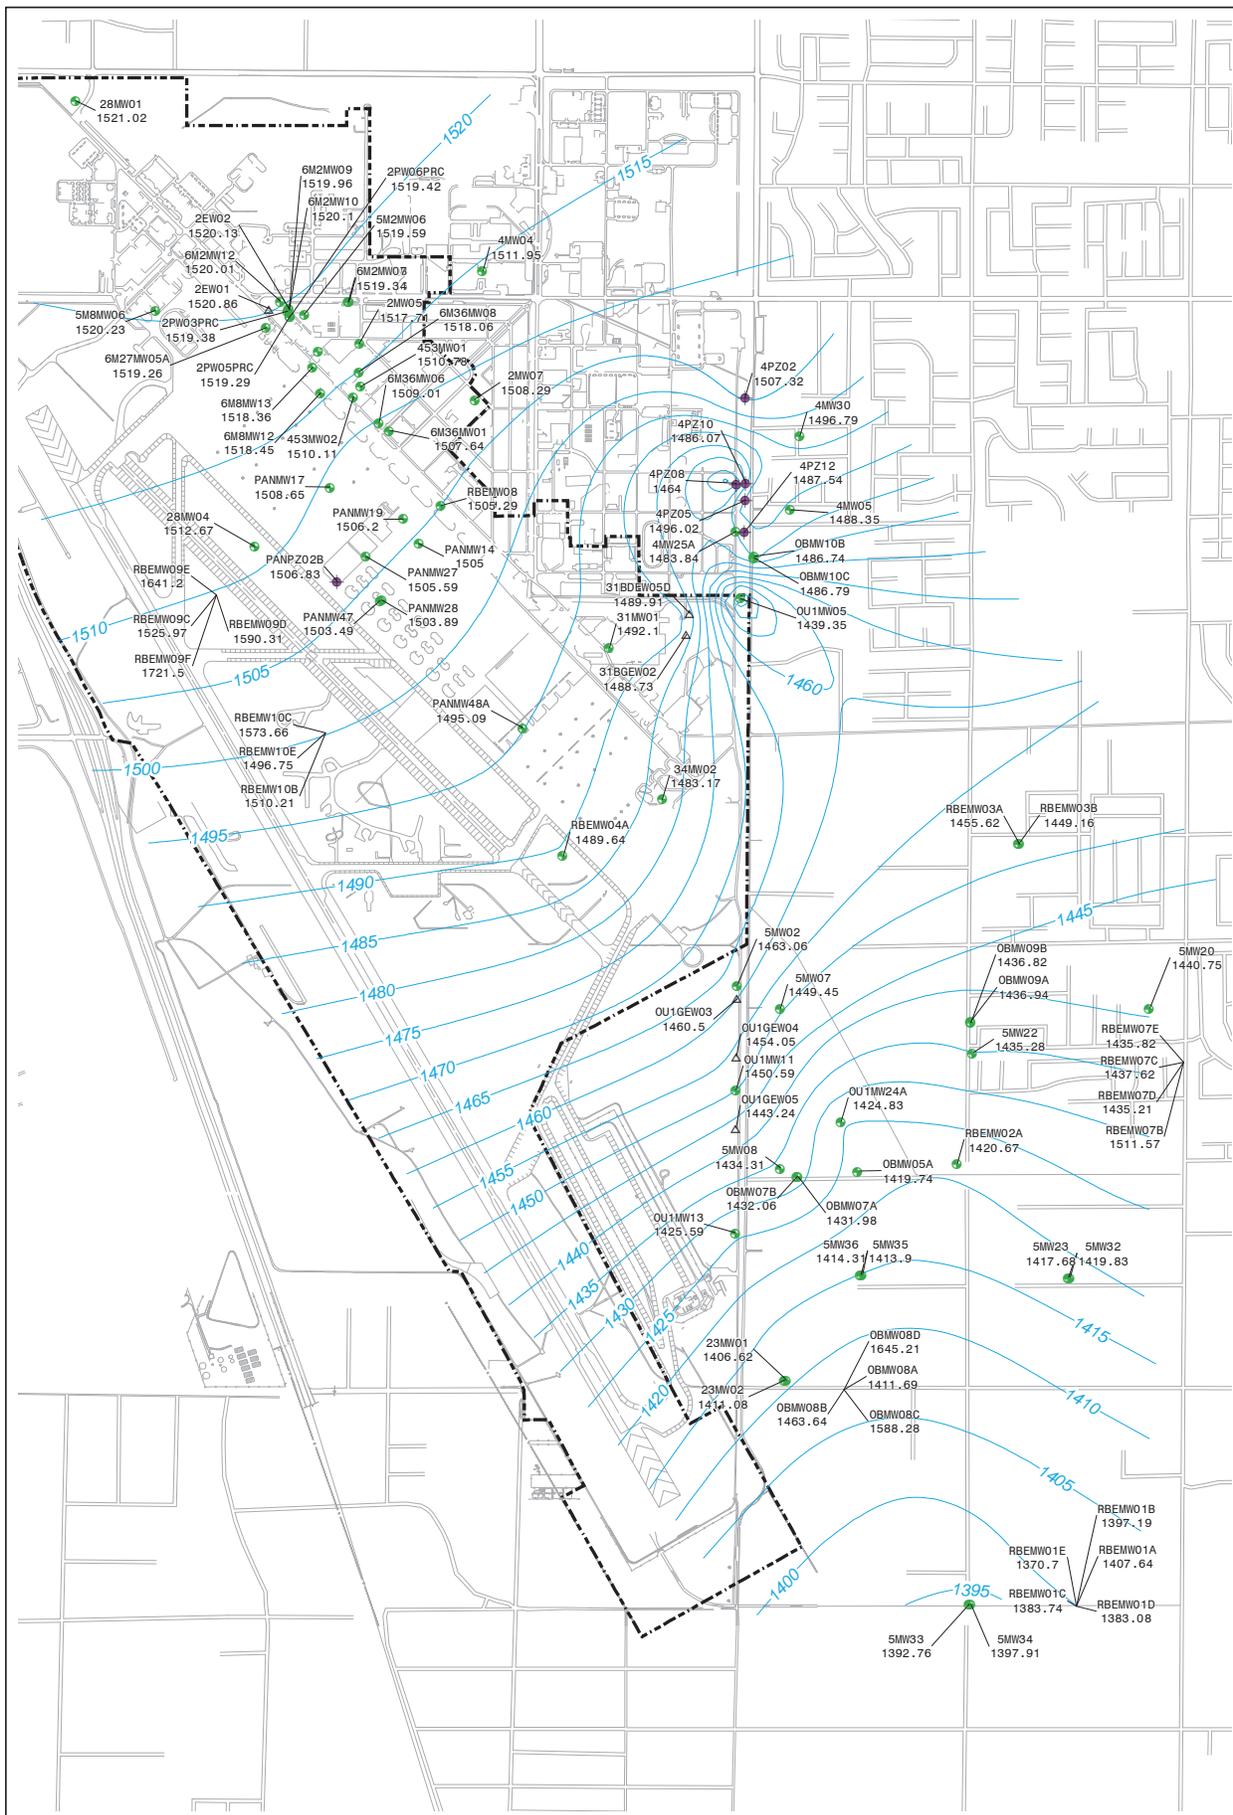
2011-2012 AGMR		Lower Alluvial Basewide Potentiometric Surface Map Fourth Quarter 2011	
Date	04-13	AECOM	Figure 2-2
Project No.	60271680		
March ARB and Former March AFB, CA

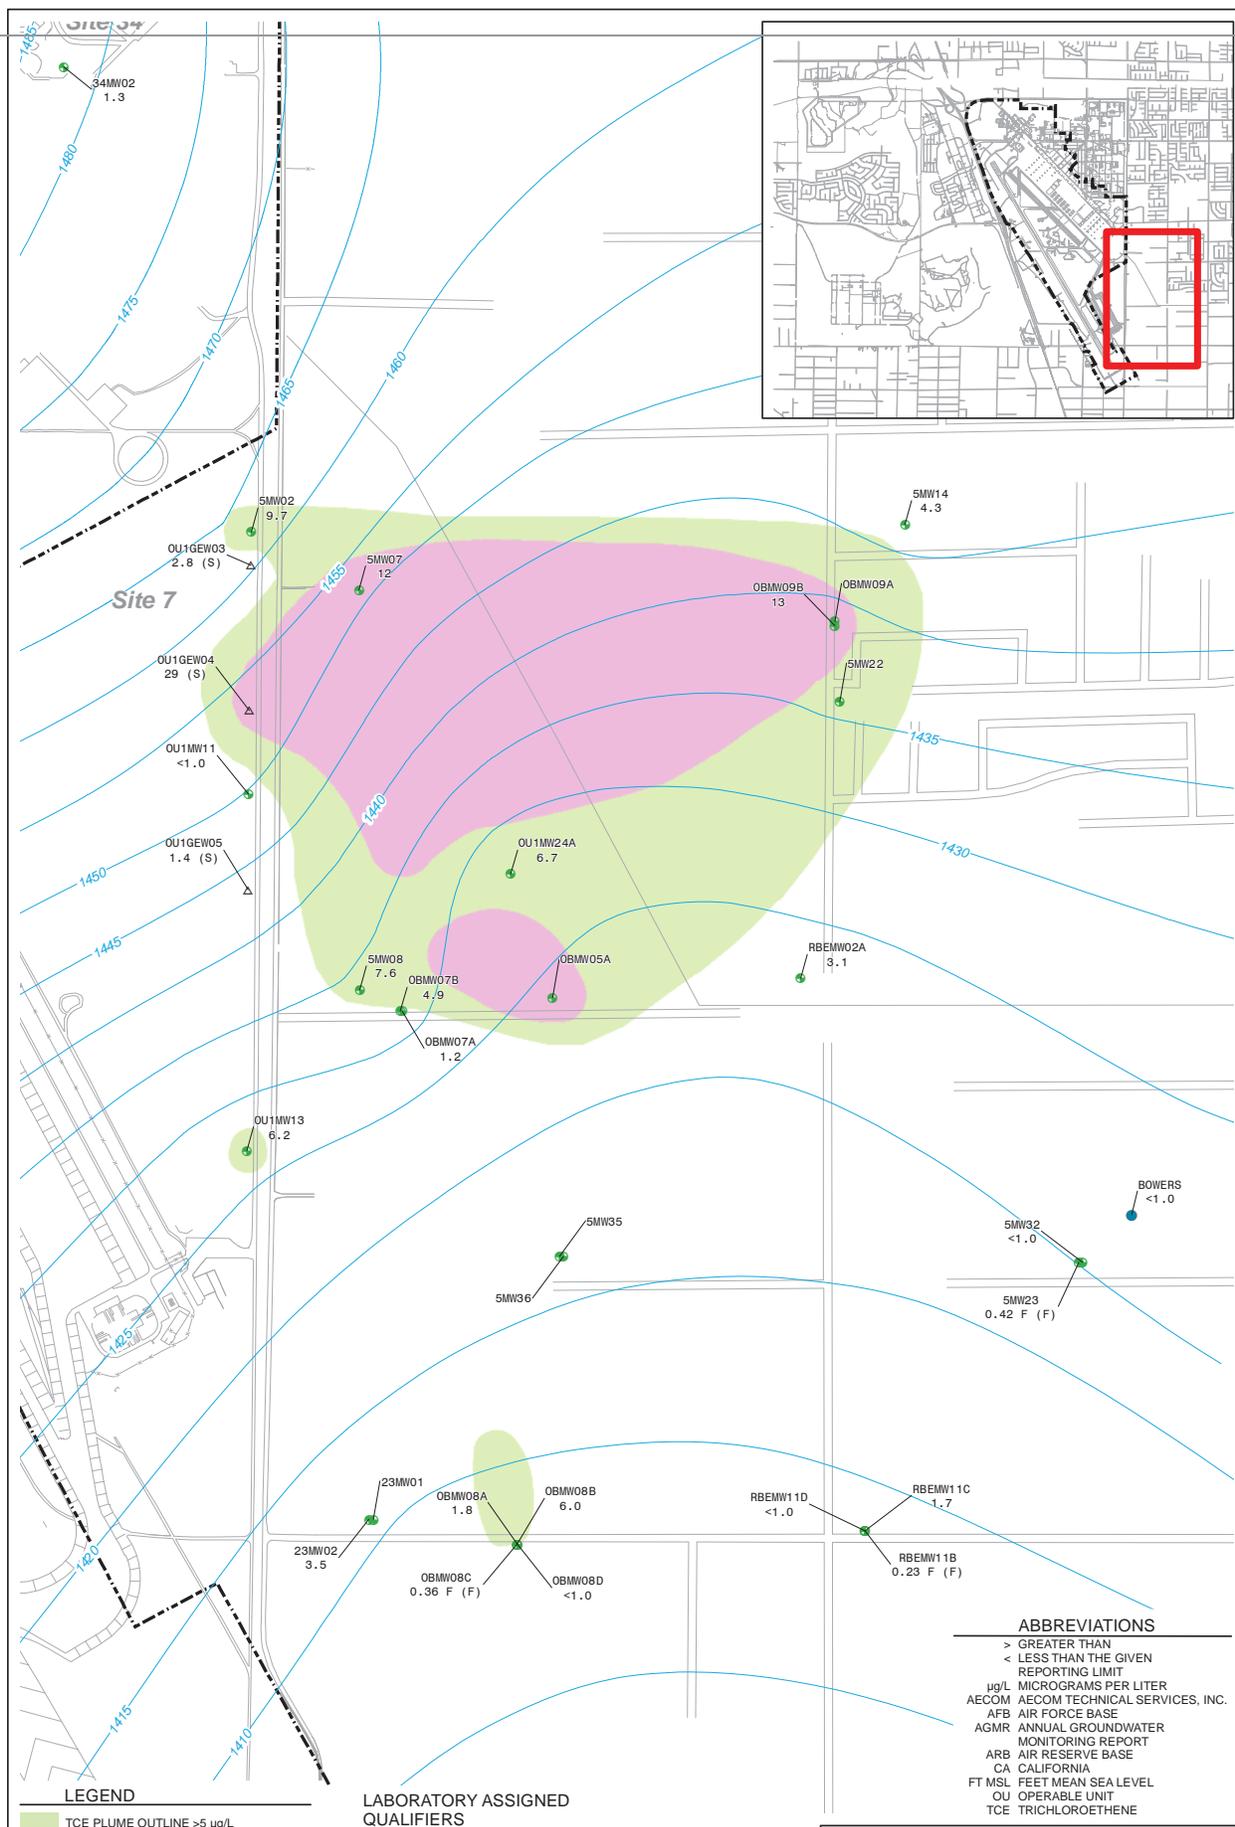
Figure 4-17

- TCE PLUME OUTLINE >5 µg/L
- TCE PLUME OUTLINE >10 µg/L
- SECOND QUARTER 2012 GROUNDWATER ELEVATION CONTOURS (FT MSL)
- BASE PROPERTY LINE
- GROUNDWATER WELLS
- EXTRACTION WELL
- MONITORING WELL
- PRIVATE WELL

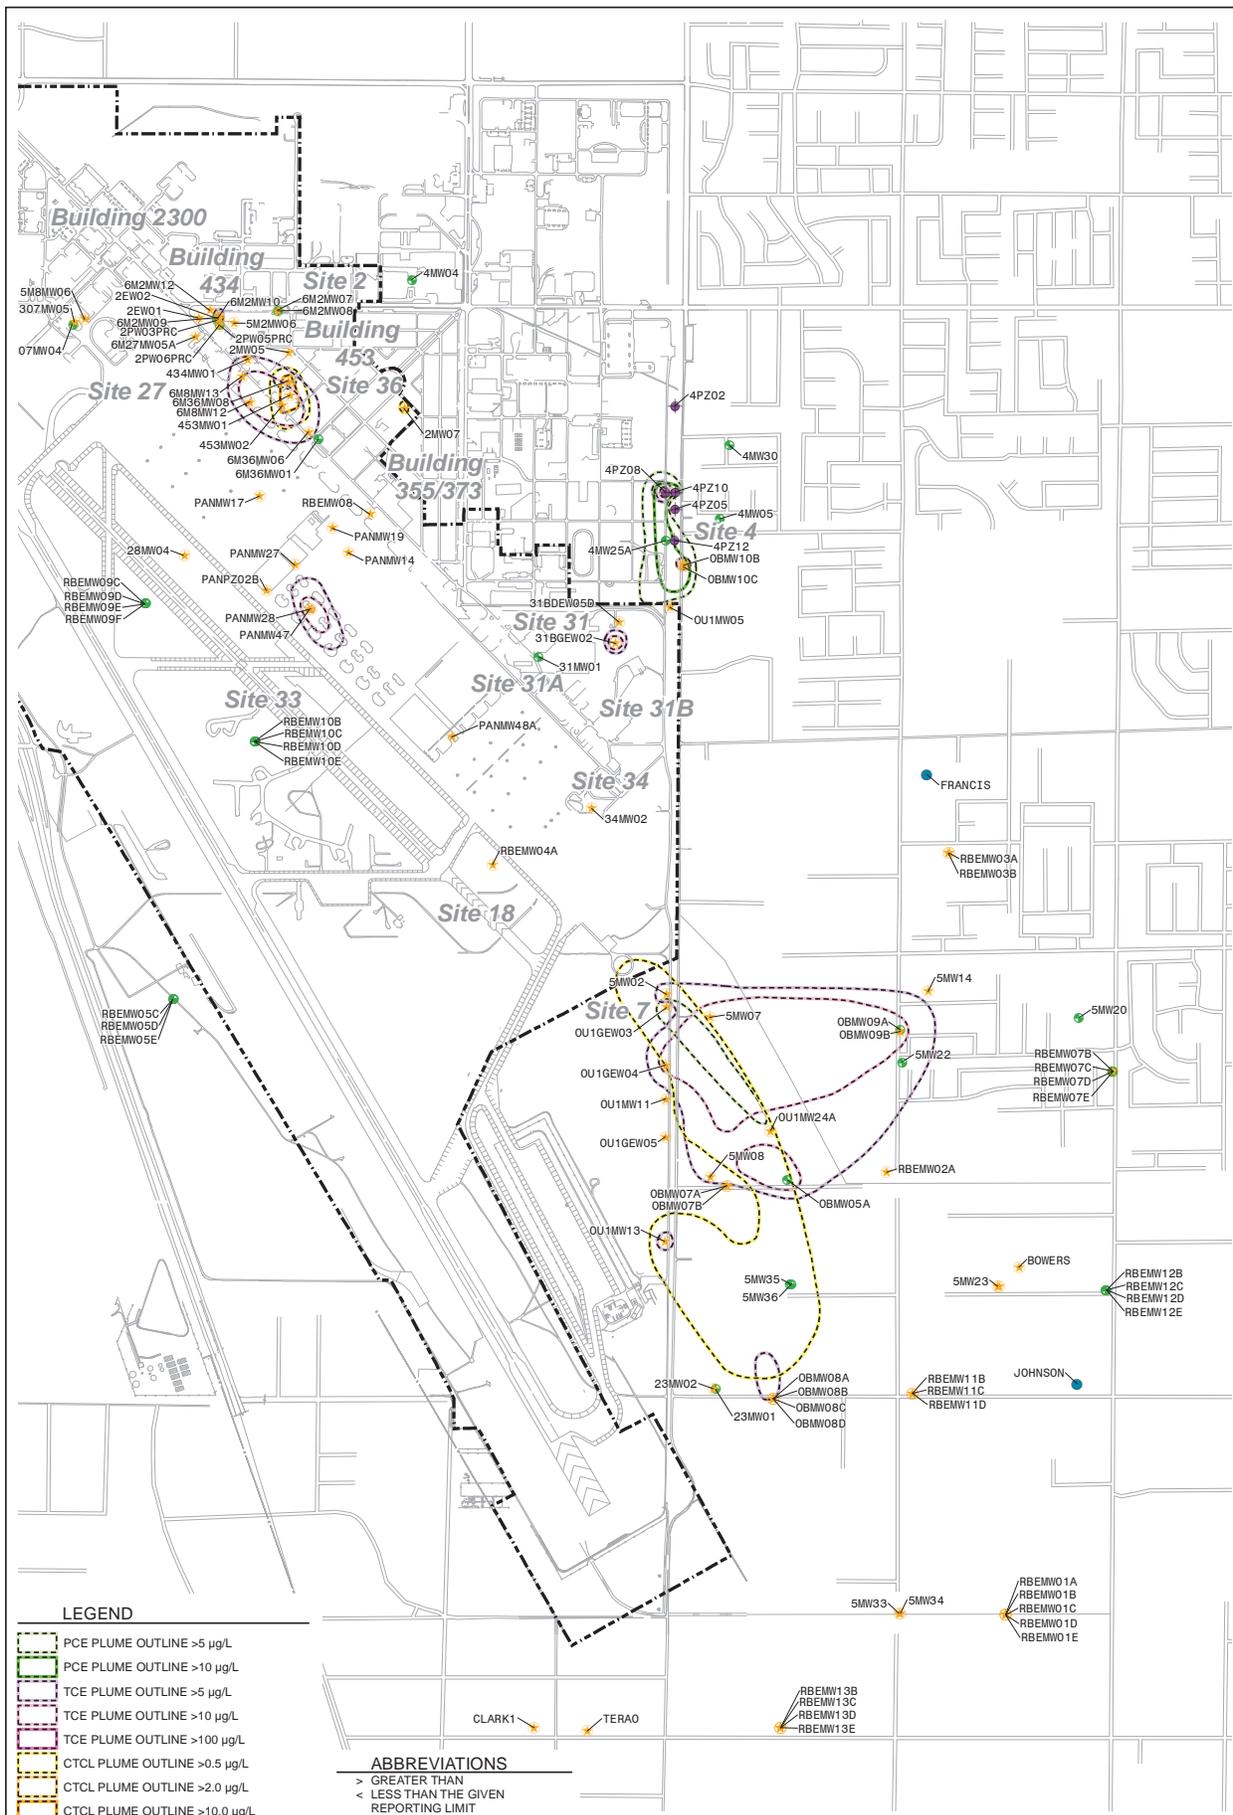
2011-2012 AGMR		Basewide Lower Alluvial Chlorinated Solvent Plumes 2nd Quarter 2012	
Date	12-13	AECOM	Figure
Project No.	60271680	March ARB and Former March AFB, CA	3-4
